Case Report

Blending the Appearance of All-Ceramic Crowns in Fluorosis Condition with Direct Chair-Side Technique

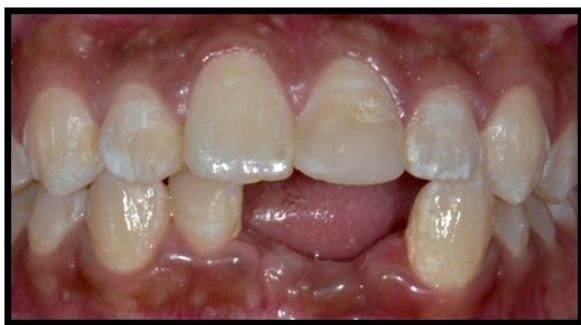
ago and sustained uncomplicated fracture of 21. Direct composite resin restoration was provided, however the direct restoration had poor aesthetical value and did not blend with the patient's generalized fluorosis condition (Fig 1A).

Figure:1A- Pre-operative condition of tooth 21 (Case 1)

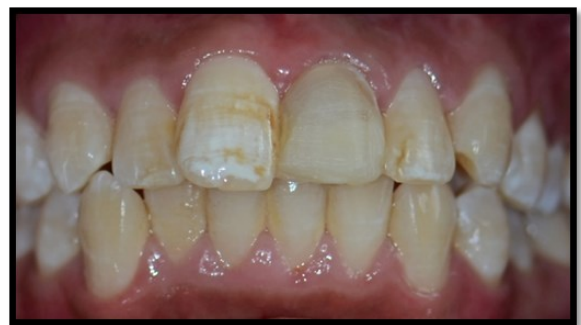
A 22-year-old male was referred to the Centre of Restorative Dentistry Studies for further restorative management of his unsightly endodontically treated upper left central incisor (21) (Fig. 1B). Radiographical investigation found a poorly done endodontics treatment with insufficient length of post on the tooth, which denotes the need for endodontics re-treatment.

Figure: 1B- Pre-operative condition of tooth 21 (Case 2)

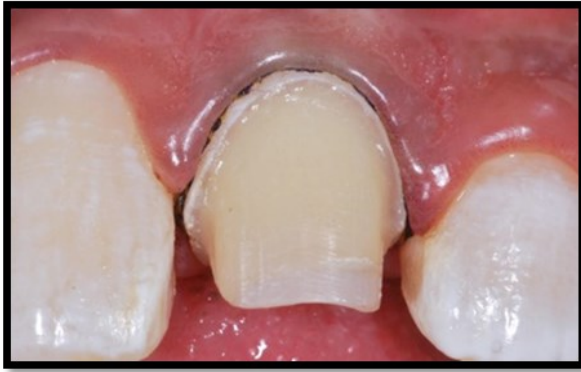
Shade selection was taken under natural light using the shade guide (VITA Toothguide 3D-Master, California USA). A 1.0mm labial and palatal reduction and 1.5mm incisal reduction was made with supra-gingival shoulder margin all around (Fig 2A & 2B). A provisional crown was fabricated using bis-acryl material (Protemp™ 4 Temporisation Material, 3M ESPE USA) to provide provisional optimum aesthetical and functional values.

Figure: 2A- Tooth preparation for bonded all-ceramic crown on 21 (Case

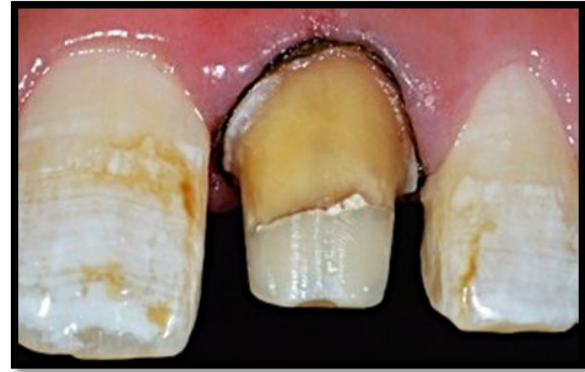
Figure: 2B- Tooth preparation for bonded all-ceramic crown on 21 with composite core and fiber post (Case 2)

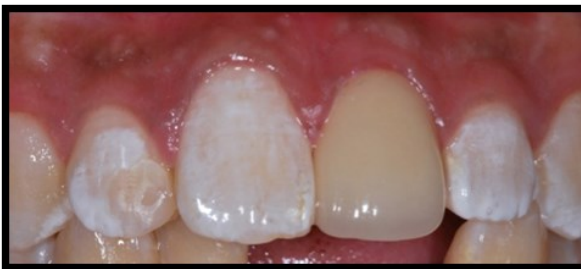
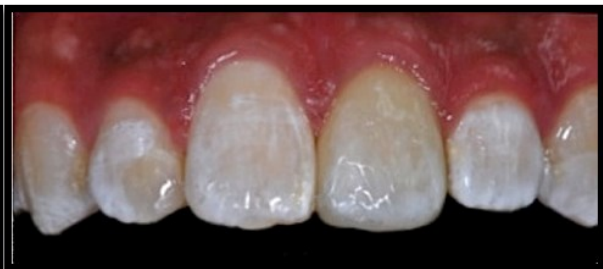
Figure: 3A- Crown 21 before and after characteristics staining (Case 1)

The fabricated crowns were seated intra-orally and the contacts and occlusion with adjacent and opposing teeth were checked. Once satisfied, the crowns were removed from the tooth preparations. Direct staining methods started with the extra-oral application of a porcelain-etching agent (hydrofluoric acid 7-9%) on the labial surface of the crown for 10 to 15 seconds.

The acid was then washed thoroughly for 60 seconds and dried completely. Next, silane was then applied and left to dry. Place the crowns intra-orally and the fluorosis condition of the adjacent teeth was then mimicked and matched on the all-ceramic crowns by using a light-cured resin color modifier and opaquing kit (Kolor+Plus, Kerr). The resin colour modifiers were applied in very thin layers; bit-by-bit to create the fluorosis characteristics using a fine tip brush. Once the characteristics coloring completed, the composite resin staining material was light cured for 15 seconds. Then the crowns were removed from the intraoral environment and a thin layer of translucent composite resin (acts as a protective layer) was placed covering the whole labial surface of the characterized crowns. The protective layer is light-cured for 30 seconds and the labial surfaces were then polished until smooth and shiny.

Cementations of the crowns were done with composite resin luting cement (Calibra[®] Esthetic Resin Cement, Dentsply) in a strictly practiced moisture control. Patients were happy and satisfied with the prosthesis provided to them (Fig 3A & 3B).

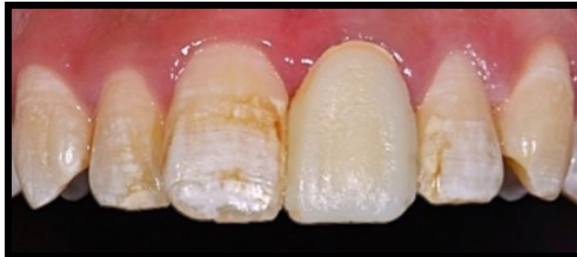
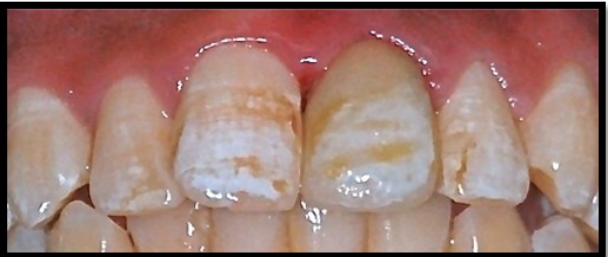
Figure: 3B- Crown 21 before and after characteristics staining (Case 2)
